Forecast link: <u>GNFAC Avalanche Forecast for Mon Feb 29, 2016</u> No Region, 2016-02-28

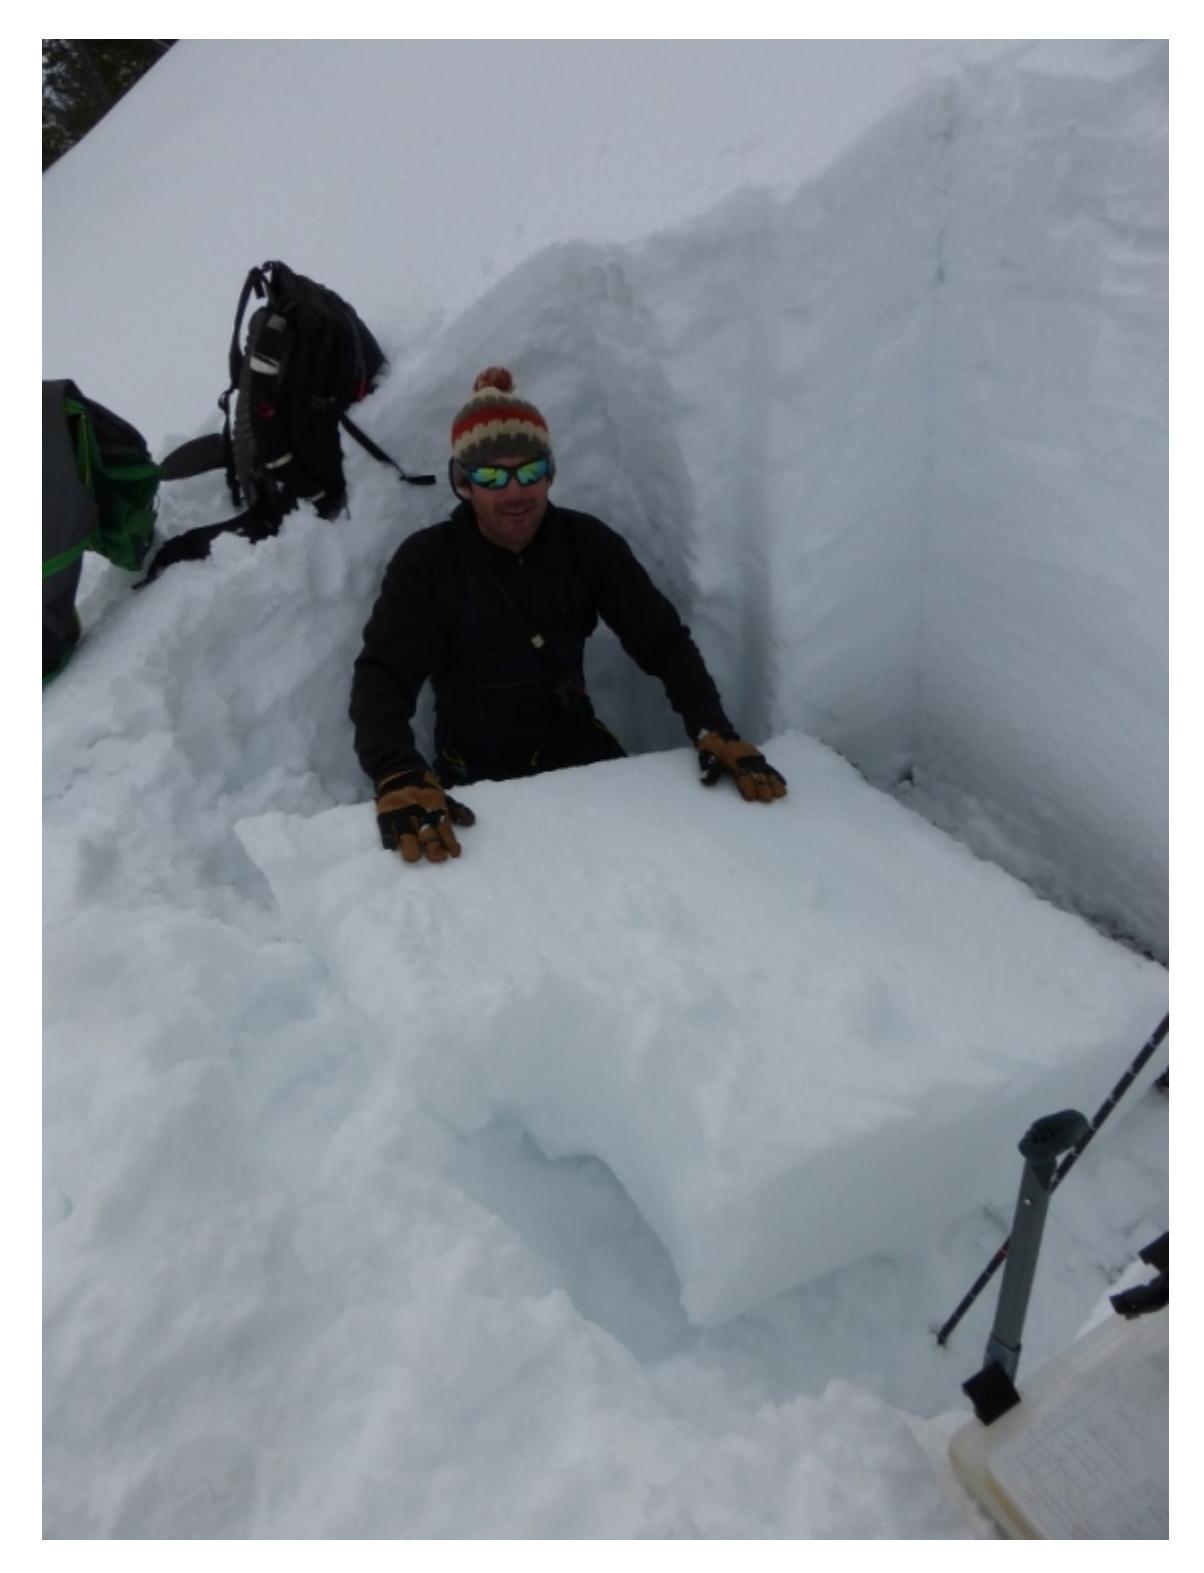
Bridger Bowl Ski Patroller Graham Turnage investigates a stable snowpack on Buck Ridge. This photo was taken on an east facing slope at 9,200 ft. Avalanches failing on layers buried deep in the pack are unlikley. Photo GNFAC
